**Repairing
Aluminum
Wiring**

U.S. Consumer Product
Safety Commission
Washington, D.C. 20207

ALUMINUM WIRING

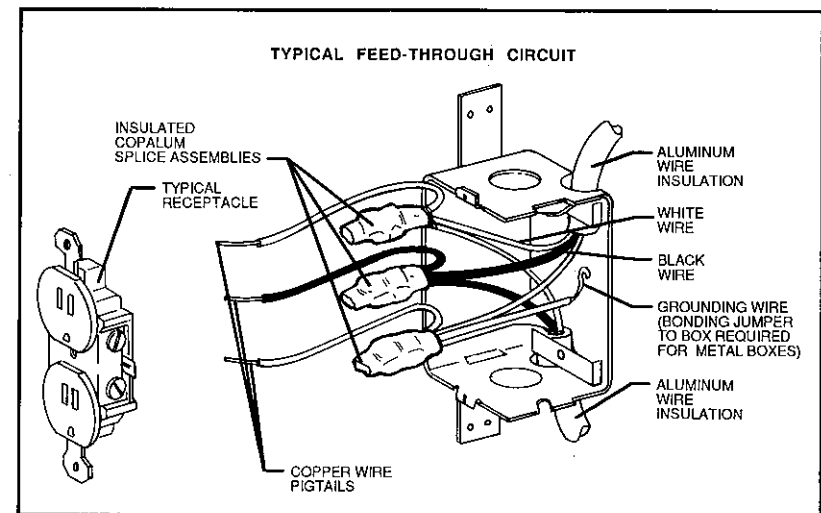
Recommended COPALUM Crimp Connector Repair

- ◆ The crimp connector repair consists of attaching a piece of copper wire to the existing aluminum wire branch circuit with a specially designed metal sleeve and powered crimping tool. The metal sleeve is called a COPALUM parallel splice connector and is manufactured only by AMP Incorporated. This special connector can be properly installed only with the matching AMP tool. This tool makes a permanent connection that is, in effect, a cold weld. An insulating sleeve is placed around the crimp connector to complete the repair.

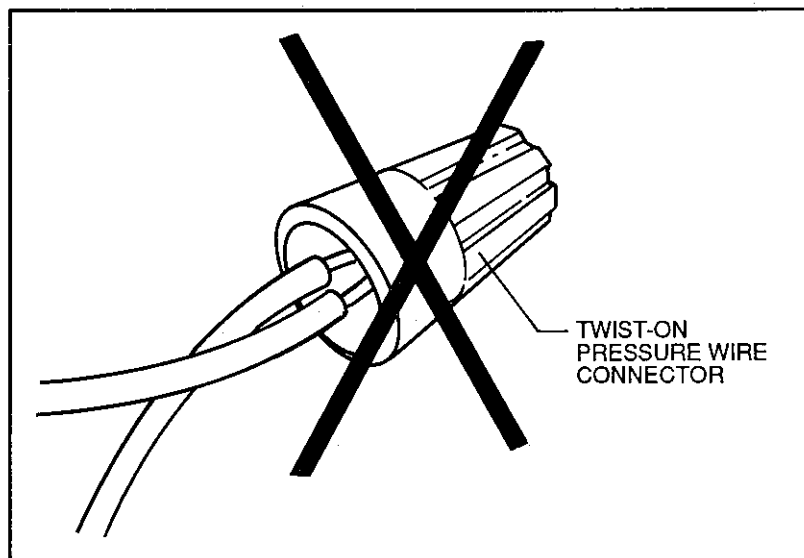
"Pigtailing" Is Not a Recommended Repair

◆ The first repair ("pigtail") involves attaching a short piece of copper wire to the aluminum wire with a twist-on connector sometimes called a wire nut; the copper wire is connected to the switch, wall outlet or other termination device. The Commission staff has evaluated the effectiveness of "pigtail" as a repair. In CPSC-sponsored laboratory testing some brands of twist-on connectors have performed very poorly. Over time, substantial numbers of these connectors have overheated in laboratory tests. Surveys of and statements made by electricians and electrical inspectors confirm the highly variable and often poor performance of these connectors when used with old technology aluminum wire. It is possible that some pigtail "repairs" made with twist-on connectors may be even more prone to failure than the original aluminum wire connections. Accordingly, the Commission staff believes that this method of repair does not solve the problem of overheating present in aluminum branch circuits.
